SEISMIC SAFETY ELEMENT  
OF THE ALAMEDA COUNTY GENERAL PLAN

*ms slip*  
Alameda County Planning Commission

July 31, 1975

## 2- SEISMIC SAFETY ELEMENT

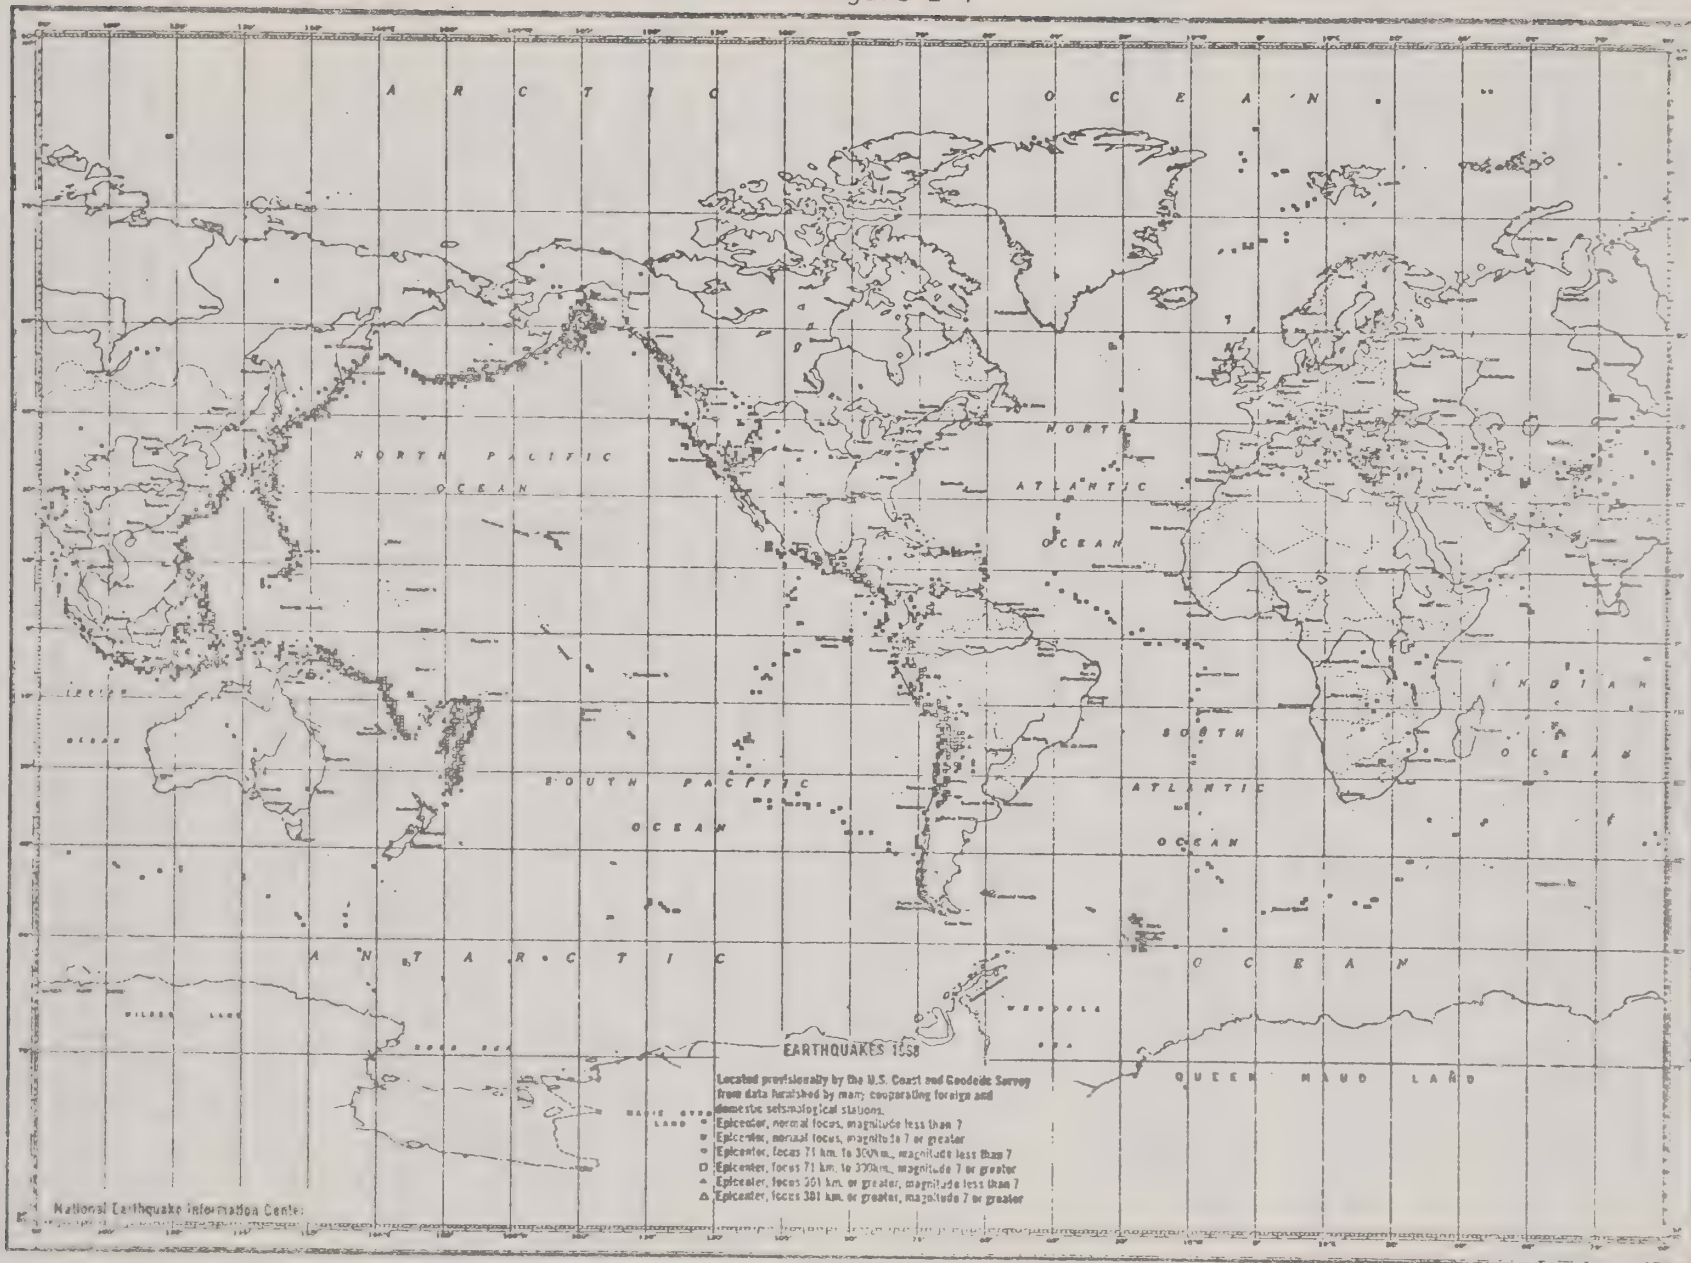
Figure 2-1

Each symbol on this map represents the epicenter of one or more earthquakes at a specific location. In the case of multiple earthquakes in highly active areas only one symbol is plotted. Consequently, 2,172 symbols are plotted, representing a total of 5,695 epicenters.
